MARINE SAFETY ALERT

Safety Alert 07-22

UNEXPECTED DANGERS: LIFEBOAT REMOTE CONTROL WIRES

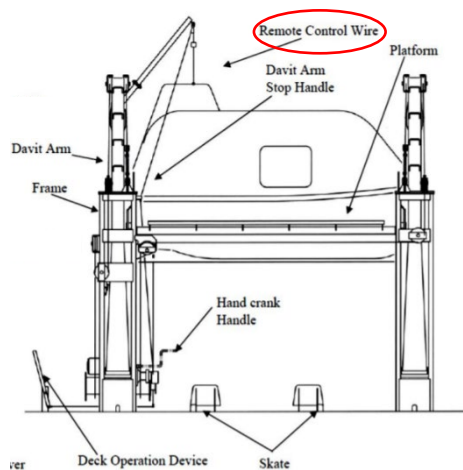
Figure 1 - Davit Launched Lifeboat Arrangement.

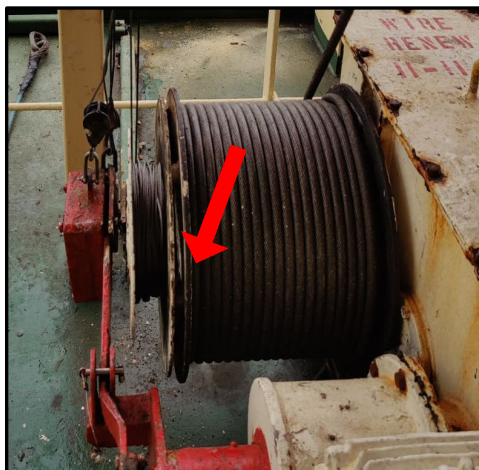
Figure 2 - Poorly-spoiled Remote Control Wire.

- (1) The first occurred when the remote control wire parted as the lifeboat was being lowered to the waterline with crew on board. Causal factors included poor winch spooling potentially hidden under the outer spools, which led to a wire kink and winding on itself, creating enough force to part the wire.

- Verify the proper spooling of the remote control wire, expand inspection as necessary.
- Verify the proper position of the remote control wire weight. If the weight is very close to the top of the lifeboat, this may indicate the remote control wire is too long.
- Verify material condition of the shackle that connects the pull cable to the remote control wire within the lifeboat. These steel shackles can corrode in the elements and may be overlooked during weekly/monthly/annual inspections.
