# UNITED STATES COAST GUARD

## MARINE SAFETY ALERT

Safety Alert 04-23

## **INFLATABLE BOAT SAFETY: DO NOT OVER-PRESSURIZE!**

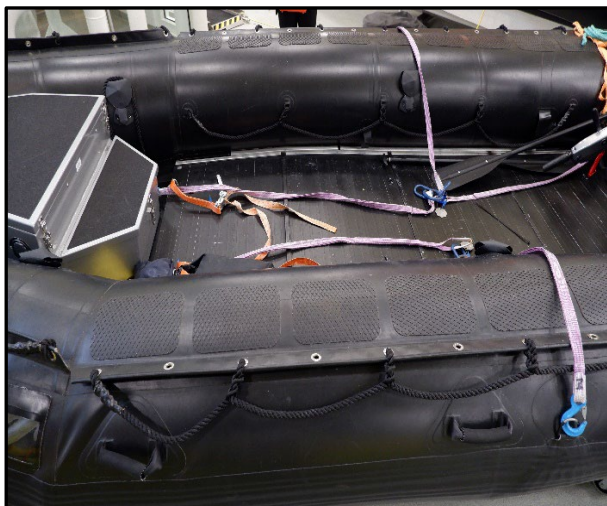
*Figure 1 -Zodiac after bladder failure. Deformation to the deck is visible.*

During a recent investigation of an incident that occurred involving foreign cruise vessel operations in the Antarctic, a U.S. passenger was severely injured due to a Zodiac MILPRO model FC 580/MK5 keel bladder failure while underway on a sightseeing excursion. In calm weather, the keel bladder suddenly ruptured, sending the passenger several feet into the air before landing onto the deck and sustaining serious injuries including a fractured femur. Another passenger was thrown overboard into the freezing water, risking hypothermia.

- Review all manufacturer recommendations for inflatable boat filling and maintenance to verify those procedures are being followed prior to any boat operations including passenger excursions.
- Use manufacturer recommended inflation devices (e.g., a foot pump) and appropriate pressure measurement tools to avoid over-pressurization.
- Verify that company policy addresses manufacturer recommendations and that crews are properly trained before operating and performing maintenance on inflatable boats.
- Contact the manufacturer of your inflatable boats for any additional recommendations and/or training options they may offer.

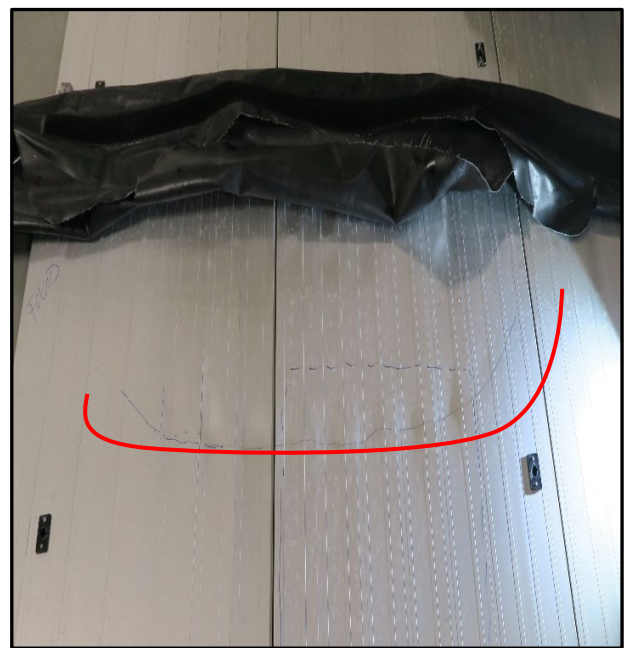
An investigation has identified that the keel bladder suffered a rupture due to excessive pressure in the tube. The recommended operating pressure by the manufacturer is 3.4 pounds per square inch (p.s.i) or 240 millibar pressure (mb). An on-scene survey of multiple inflatables on board the cruise ship noted pressures up to and exceeding 9 p.s.i. (620 mb) in other keel bladders. The keel bladder is not protected by a safety relief valve, and the manufacturer recommends that they be inflated with a foot pump to reduce the chance of over-pressurization. However, crewmembers were routinely using an air compressor to fill the buoyancy chambers (including the keel tube) prior to the incident. In addition, pressure levels were not being checked using a manometer as recommended by the manufacturer.

*Figure 2 – Ruptured keel bladder and the view of the underside of the metal hull. The red line has been added to highlight the deformities in the hull metal due to the keel bladder rupture.*

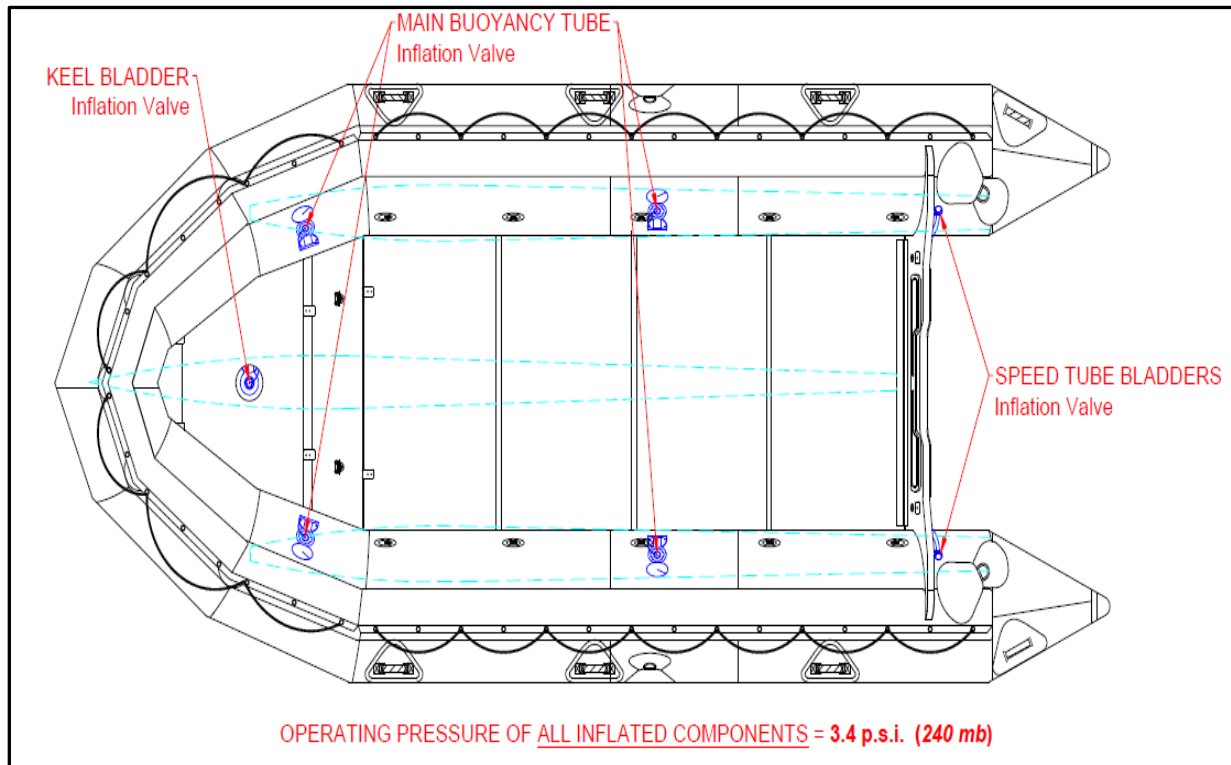
*Figure 3 – Diagram of Zodiac MILPRO.*
