**Resolution A.866(20)**  
*Adopted on 27 November 1997*  
*(Agenda item 9)*

**GUIDANCE TO SHIPS' CREWS AND TERMINAL PERSONNEL FOR BULK CARRIER  
INSPECTIONS**

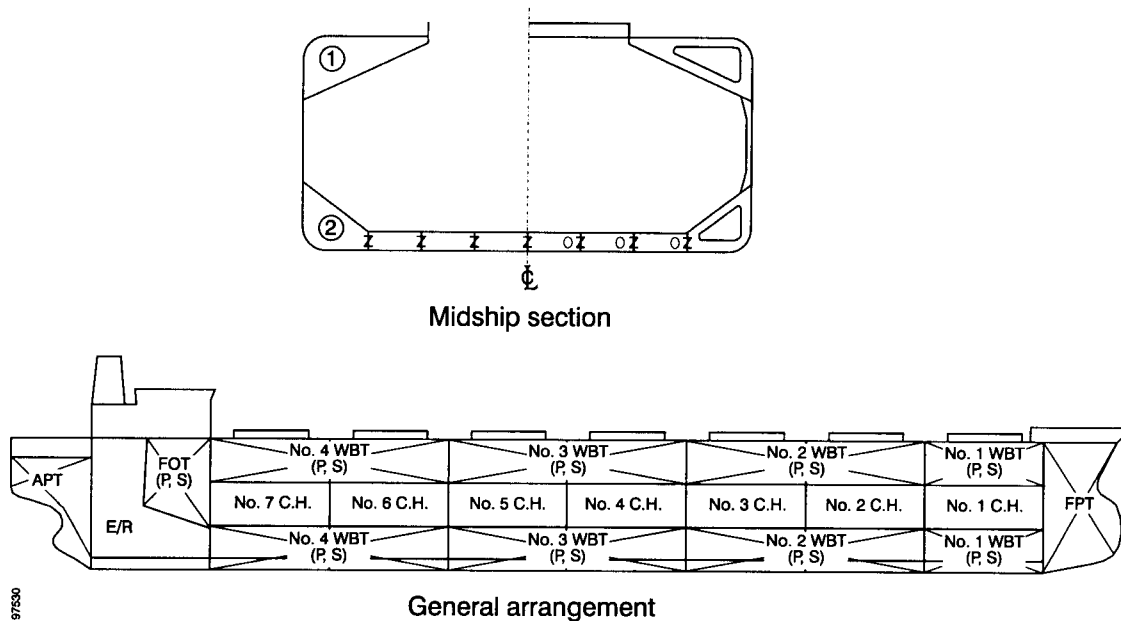
**4.1 Bulk carrier:** a bulk carrier is a cargo ship intended for carriage of dry bulk cargoes such as grain, coal, ore, etc., provided with topside tanks at both shoulders and bilge hoppers in both double-bottom wings in the cargo space. Below is a typical midship section and general arrangement.

Figure 1 – Typical midship section and general arrangement

**4.2 Topside tank:** tanks provided in cargo spaces at both shoulders, as the space (1) shown in the drawing above.

**4.3 Bilge hopper:** a conventional bulk carrier has hopper structures at both bottom wings in cargo holds. This part of the cargo hold is called the 'bilge hopper'. Double-bottom tanks in way of bilge hopper are often called 'bilge hopper tanks'. In the diagram, the space is shown as (2).

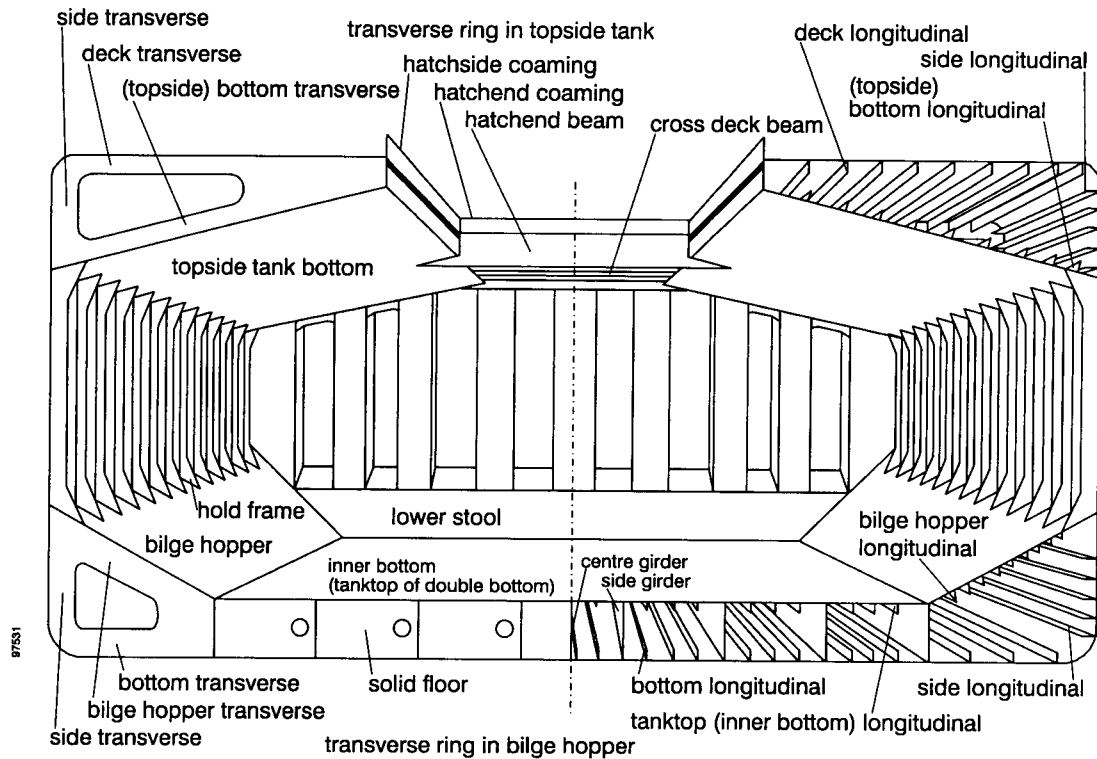
**4.7 Framing of various kinds:** on a typical bulk carrier, framing is designed as a longitudinal system in topside and double-bottom tanks and as a transverse system at cargo hold side shell. Framing fitted in ship's longitudinal direction are called 'longitudinals'. To identify them in detail, the name of the plate they are attached to is added, such as 'deck longitudinals', 'side longitudinals', 'bottom longitudinals', etc. Framing attached to the side shell in the cargo holds are called 'hold frames', 'side frames', 'main frames', 'shell frames', etc.

Figure 2 – Typical cross-section of cargo ship (bulk carrier)

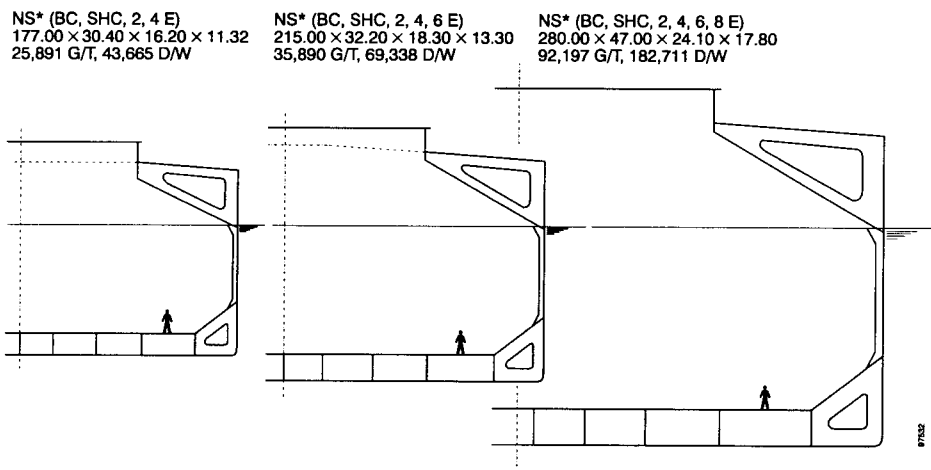
5.1 In general, bulk carriers are grouped into three categories according to size. These are: capesize, panamax, and other smaller types. Among the smaller types, ships of 30,000 to 45,000 dwt having five cargo holds are called 'handy bulkers'. Panamax bulkers are bulk carriers having a breadth of 32.2 m, and are the largest ships able to transit the Panama Canal. Ships of this kind usually have seven cargo holds and a deadweight of around 50,000 to 60,000 tonnes. Bulk carriers with dimensions greater than the panamax ships are called 'capesize bulkers'. Capesize bulkers have nine or more cargo holds and a deadweight in excess of 100,000 tonnes.

Figure 3 – Various bulk carriers

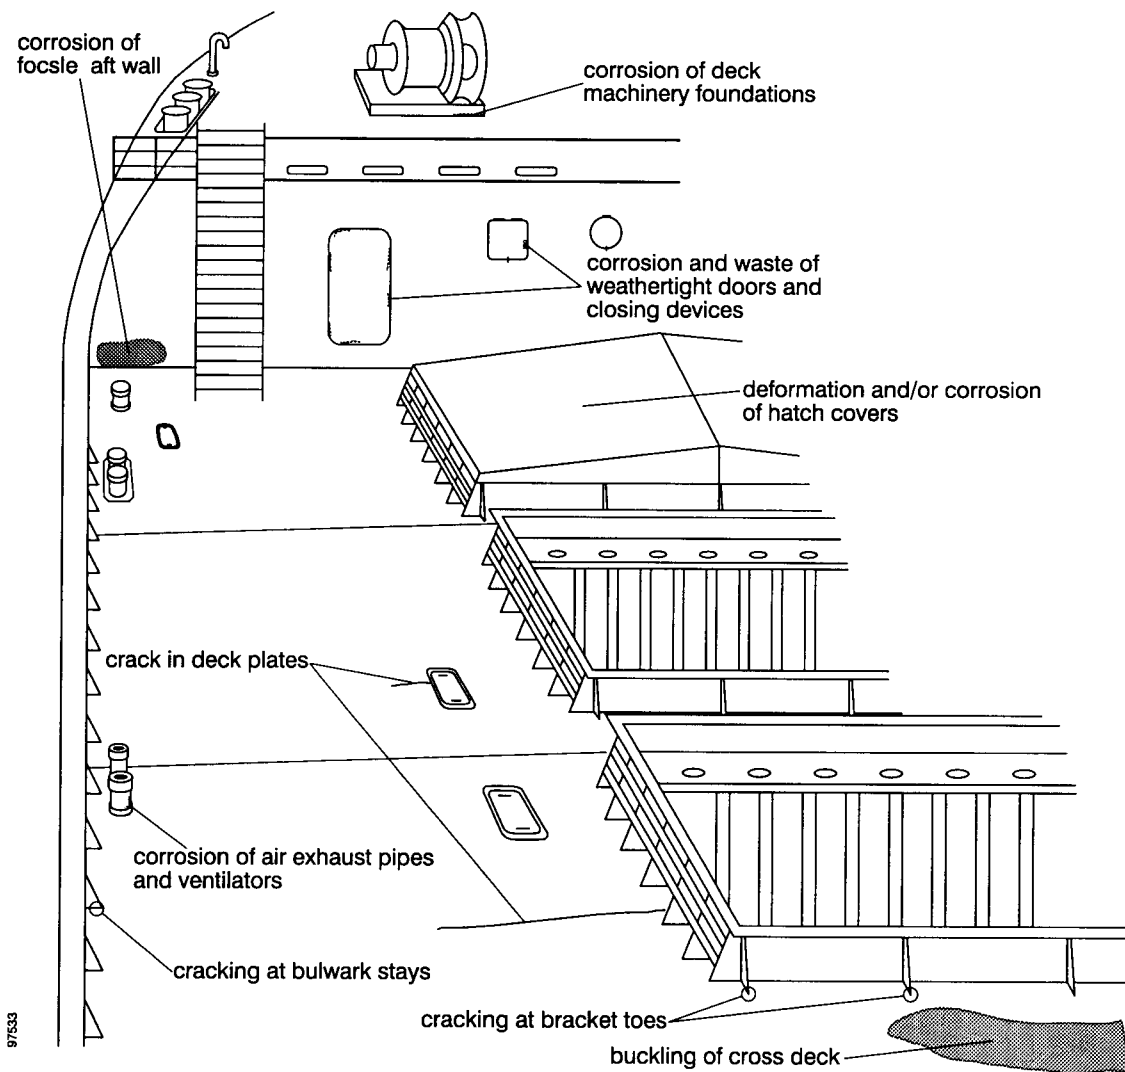
6.1.2 Bulk carriers have cargo hatchways for the convenience of cargo-handling facilities. These hatchways reduce the ship's torsional strength and invite concentrated stress at the hatchway corners which may be evident by cracking of the deck plates in these areas.

6.1.3 Cross-deck strips come under stress by transverse bending. The transverse bulkheads provide transverse strength to a bulk carrier and the cross-deck strips provide the strength to withstand the resultant axial forces in a transverse direction.

Figure 4 - Check points on the upper deck

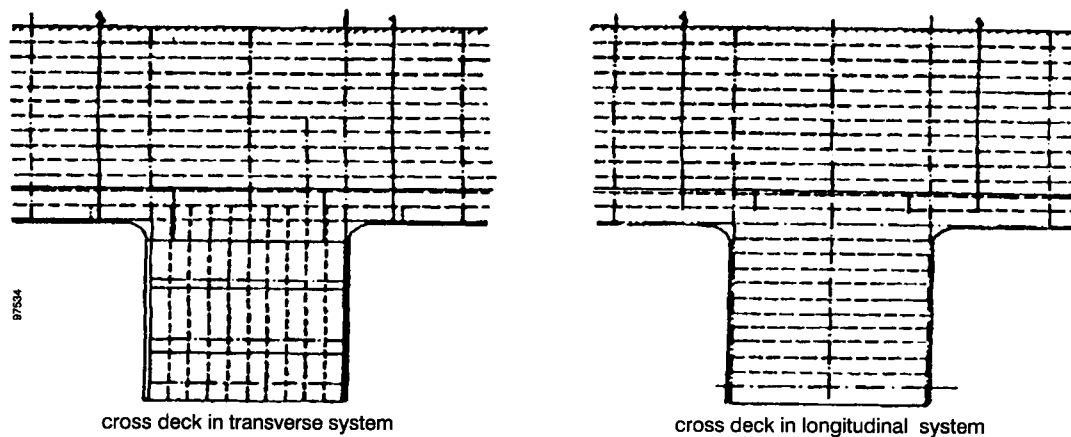
6.1.4 Generally, longitudinal beams are arranged under the longitudinally continuous upper deck outboard of the side lines of the cargo hatchways. This is called the longitudinal system. When the deck beams for cross-deck strips are also arranged in this manner, buckling of the cross-deck strips may take place due to insufficient strength against the axial forces acting on them in a transverse direction. The transverse system is the preferred method of construction for cross-deck members. Particular attention should be given to buckling of the main deck on those ships where the cross-deck strips are arranged in the longitudinal system.

Figure 5 - Comparison of stiffening systems for cross decks

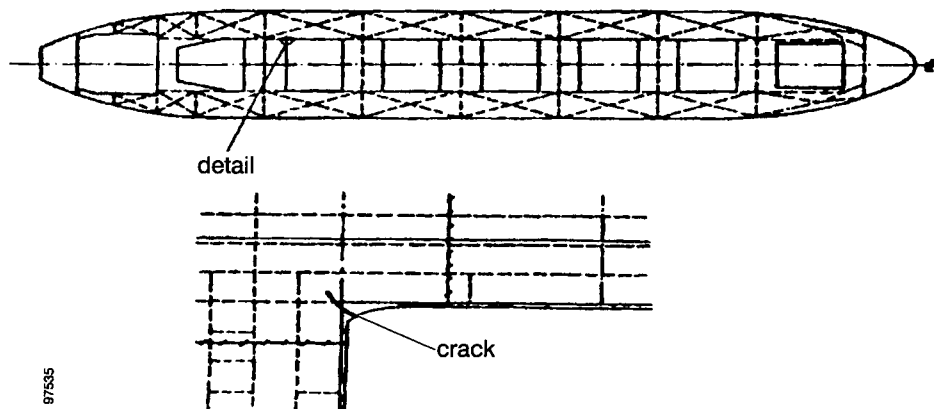
The large cargo hatchway openings reduce the torsional strength of the hull and invite stress concentration at their corners on the upper deck. In this regard, upper deck plating at hatchway corners is one of the focal points for cracking. Particular attention should be paid to these areas during inspection.

Figure 6 - Cracking at hatchway

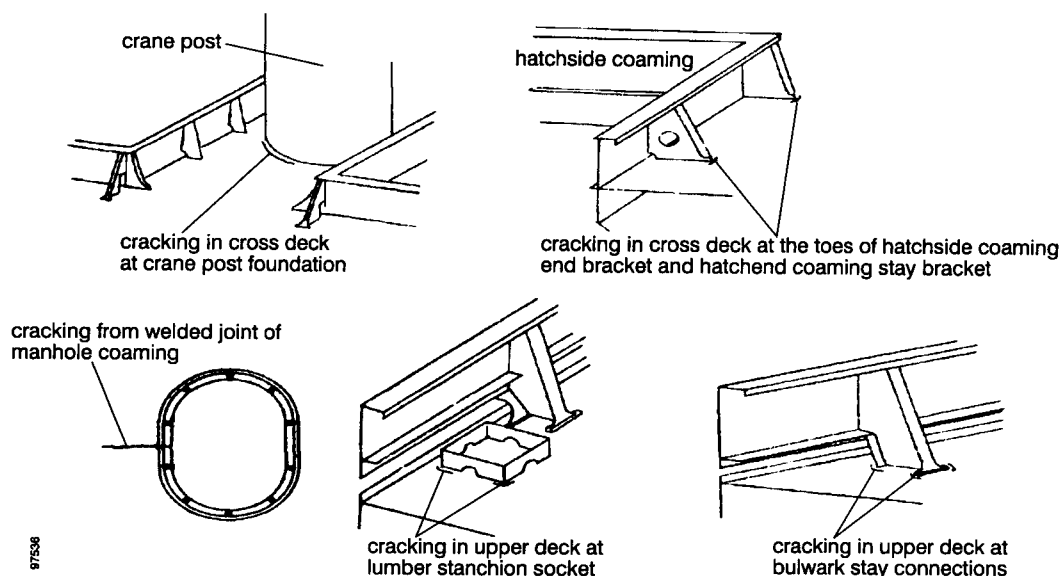
Various metal fittings are welded to the upper deck plating. These installations may cause stress concentrations at the welded joints or have defects in the welds. Deck platings in the vicinity of manholes, hatchside coaming end brackets, bulwark stays, crane post foundations and deck houses, etc. are to be carefully watched for cracking.

Figure 7 - Various crackings in upper deck plating

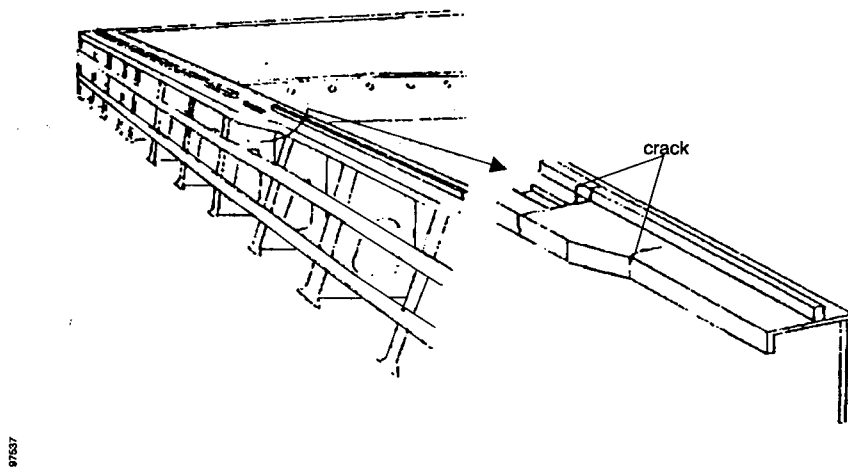
Hatch coamings are subjected to hull girder stress. Although they are not critical longitudinal strength members, they should be watched carefully to ensure that these cracks do not spread. Cracking may be initiated at defects in welded joints and metal fittings to the coamings that will invite stress concentration. Such cracking is considered serious to the ship's safety because it may be the initiation of a fracture on a large scale.

Figure 8 - Cracking in hatch coaming

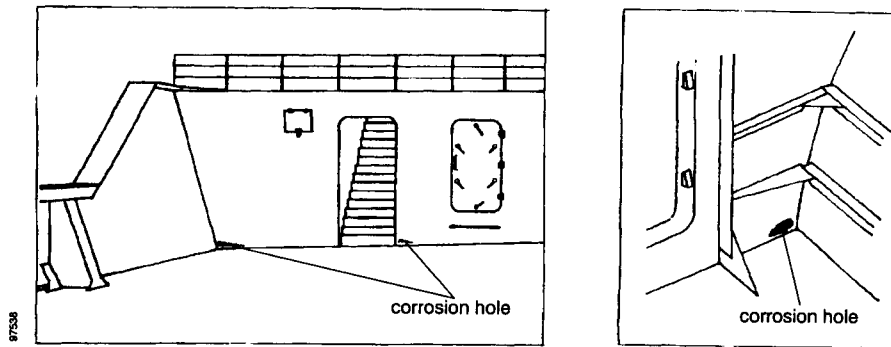
The bilges in forecastle space may cause corrosion of the bulkhead where it meets the deck. In flush-decked bulk carriers, the boatswain store aft wall may be corroded in the same manner. Large bulk carriers generally do not have forecastle and have their boatswain stores down below the upper deck in forepeak spaces. Bilges left in such spaces also cause corrosion of the aft end bulkhead which separates boatswain store and No. 1 cargo hold. Such wastage may lead to water ingress, cargo damage, cargo shifting, and/or stability problems.

Figure 10 – Forecastle end bulkhead

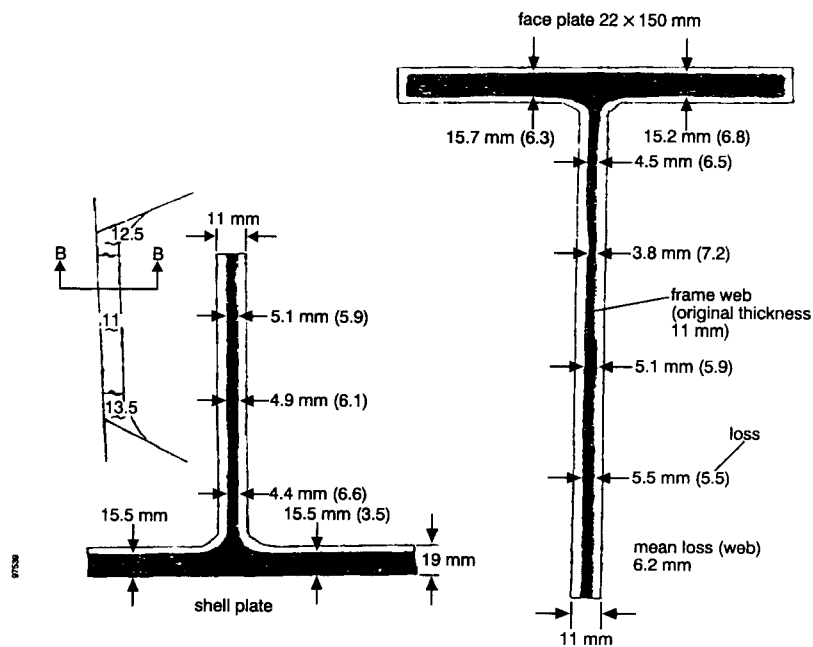
6.2.4 This may mean accelerated corrosion in the hold frames, the thinnest among all the members in cargo holds. If corrosion and waste become excessive, failure of hold frames invites additional loads to the adjacent ones, which may lead to failure throughout the side shell structure.

6.2.5 Transverse bulkheads may also be susceptible to accelerated corrosion, particularly at the mid-height and at the bottom. Particular care should be exercised when inspecting hold frames and transverse bulkheads, in that these members may appear in deceptively good condition. Tanktop and side shell plating generally corrodes from the steel surface facing the cargo hold and corrosion from inside the double bottom is usually less than that from the cargo hold side.

Figure 12 - An example of a corroded hold frame

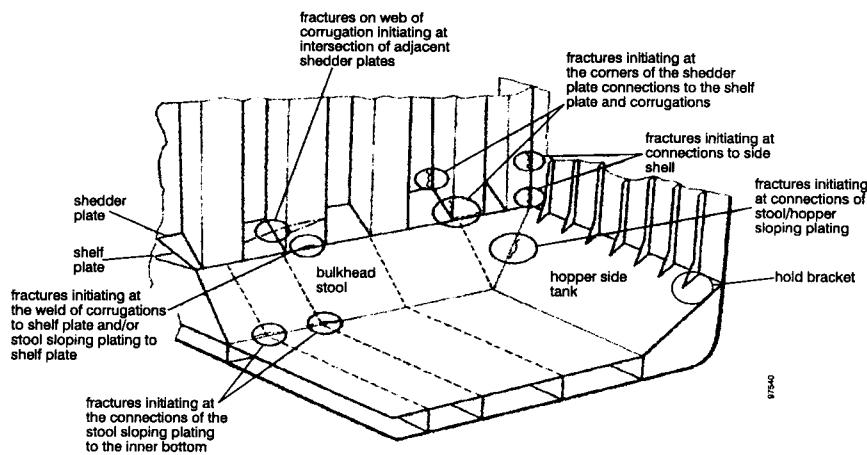
- .1 *Fractures* at the boundaries of corrugations and bulkhead stools, particularly in way of shelf plates, shedder plates, deck, inner bottom, etc.
- .2 *Buckling* of the plating/corrugations, leading to the failure and collapse of the bulkhead under water pressure in an emergency situation.

Figure 13 – Typical fracturing at the connection of transverse bulkhead structure

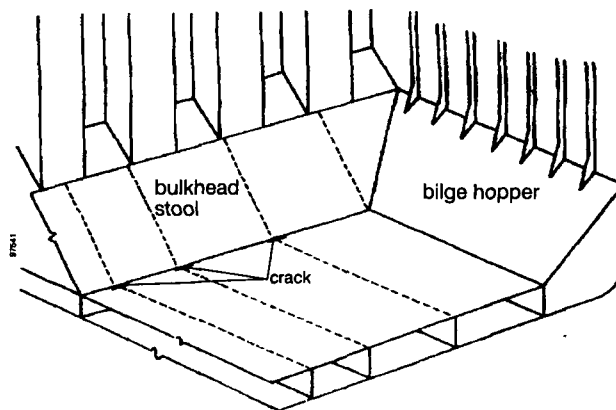
In bulk carriers having combination cargo/ballast holds, cracks may often be found at or near the connection of the stool of the transverse bulkhead and the tanktop.

Figure 14 - *Cracking at the connection of bulkhead stool and tanktop*

All capesize and panamax bulk carriers and some handy bulkers have combination cargo/ballast hold(s) to keep the necessary draught. The bulkhead boundaries of the spaces are designed to comply with the requirements for deep-tank bulkheads. In these holds cracks may often be found at the connection between the transverse bulkhead and the tanktop. These cracks can be detected by visual inspection or by noting leakage from the double-bottom tanks.

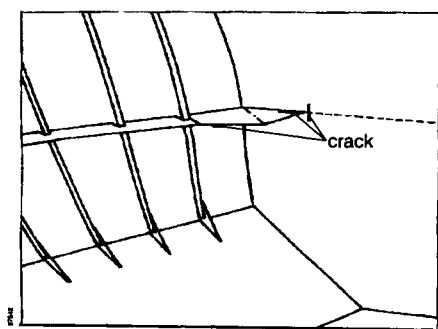
Side stringers and/or side shells in way of No. 1 cargo hold along the collision bulkhead are often found cracked. This kind of damage is considered to be caused by insufficient continuity between forepeak construction and cargo hold structure.

Figure 15 - Cracking around the collision bulkhead

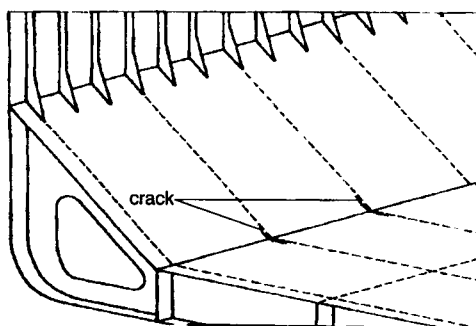
On large bulk carriers such as capesize and panamax bulkers, bilge hopper plating around the knuckle line may be cracked along the bilge hopper transverse webs. This is considered to be caused by insufficient local reinforcement.

Figure 16 - Cracking in the bilge hopper

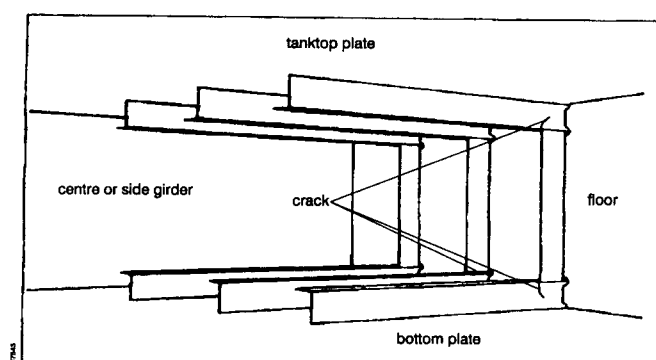
Cracks may be found in the side, bottom and/or tanktop longitudinals at intersections with solid floors or bilge hopper transverses. Cracks also may be found in the floors or transverses occurring at the corners of the slots cut for longitudinals.

Figure 17 - Cracking in tanktop/bottom longitudinals

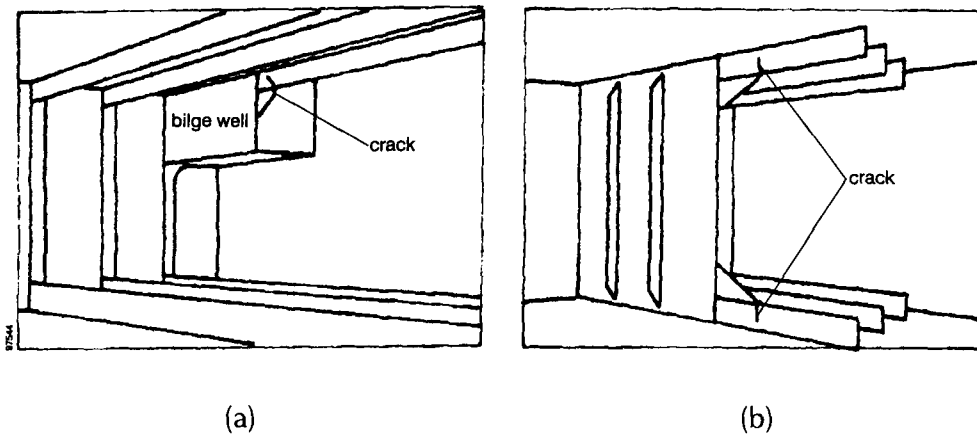
Longitudinals may be cracked at the ends of additional (partial) side girders provided in the double bottom below cargo hold bulkheads or at the side walls of bilge wells for cargo holds, due to additional stress concentration caused by the structural discontinuity at those connections.

Figure 18 - (a) Cracking at the end connection with side walls of bilge well; (b) Cracking at the end of an additional girder.

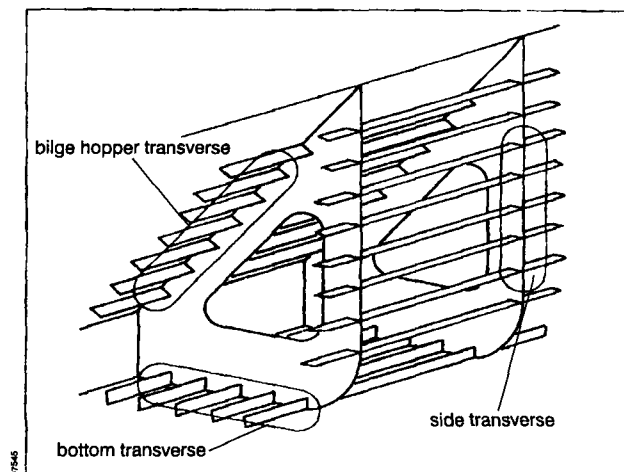
Cracks may be observed in transverse webs in bilge hoppers initiating from the slot openings for longitudinals and at the knuckled corners of the lower ends of the hoppers.

Figure 19 - Check points in bilge hopper transverse

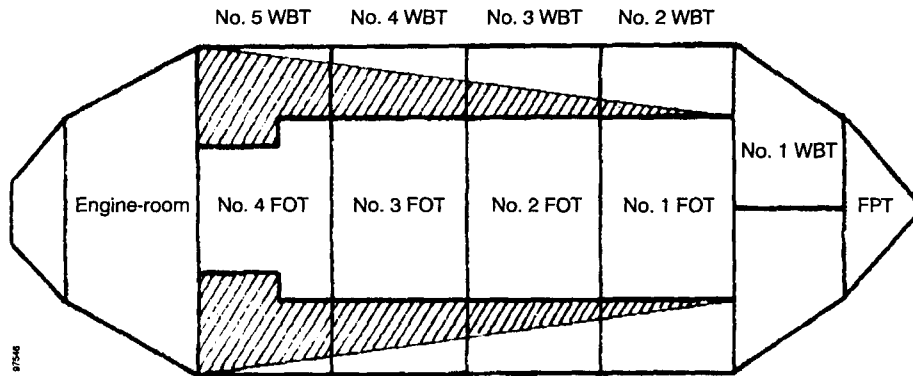
Since the late '70s, problems with heavy corrosion in double-bottom water ballast tanks adjacent to fuel oil tanks have appeared. In some cases, the corrosion was worse in areas closer to the fuel oil tank boundaries. In those ships, fuel oil tanks were installed.

Figure 20 - Areas where heavy corrosion due to heat effect may be found (hatched areas)

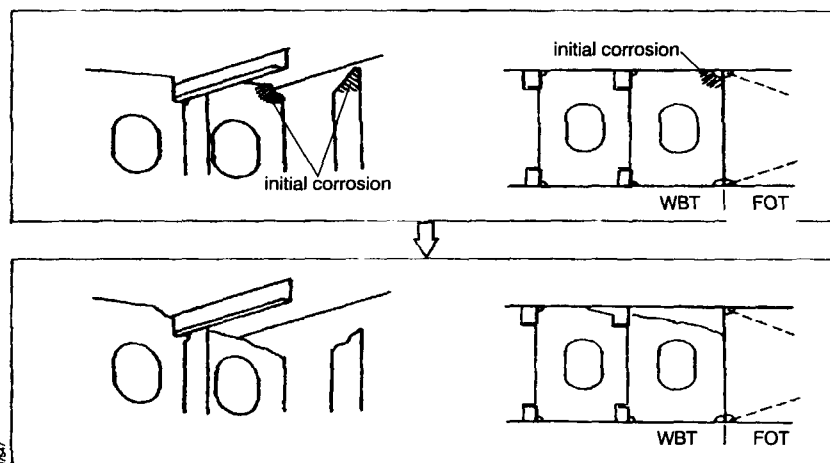
Figure 21 - Progress of corrosion in water ballast tanks adjacent to fuel oil tanks (FOT)

The fuel oil heating system was adopted following changes to the properties of fuel oil, mainly an increase in viscosity. For economic reasons, ship operators began to use low-grade bunker oil which needs heating in order to decrease the viscosity. At the beginning of this trend, the temperature required in the fuel oil tanks was not high enough to accelerate the corrosion of the steel in the adjacent spaces. However, in recent years, the grade of bunker oil being used requires the temperature in the tank to be 80°C or more. Such a temperature can accelerate corrosion of the steel in the tanks, particularly in the vicinity of the boundaries of the fuel oil tanks.

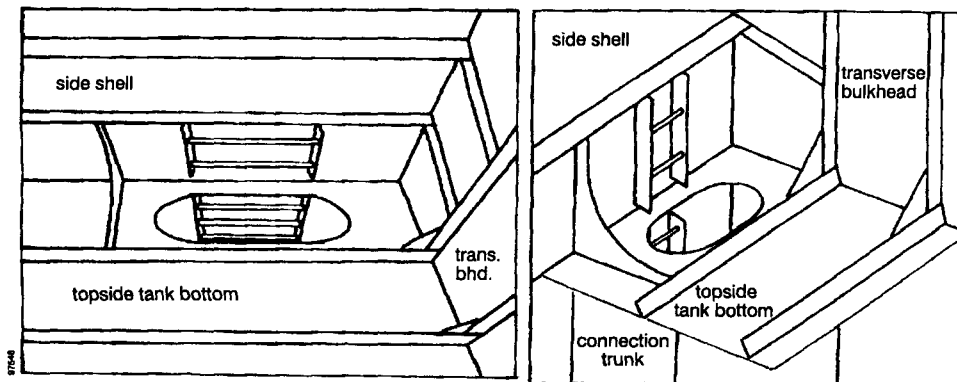
6.5.2 Connection trunks provided between topside and bilge hopper spaces are to be carefully watched for signs of corrosion and waste of the steelworks inside.

6.5.3 On some bulk carriers, bilge hopper tanks and topside tanks form one integral tank connected with trunk spaces. The inside surface of a connection trunk is liable to corrosion and should be examined carefully.

Figure 22 - Connection trunk entrance in topside tank
