CHILEAN NAVY  
DIRECTEMAR

# LESSONS LEARNED

FROM ACCIDENTS INVOLVING MERCHANT, FISHING, AND SPORT VESSELS,  
AND PORT, DIVING, AND AQUACULTURE OPERATIONS.

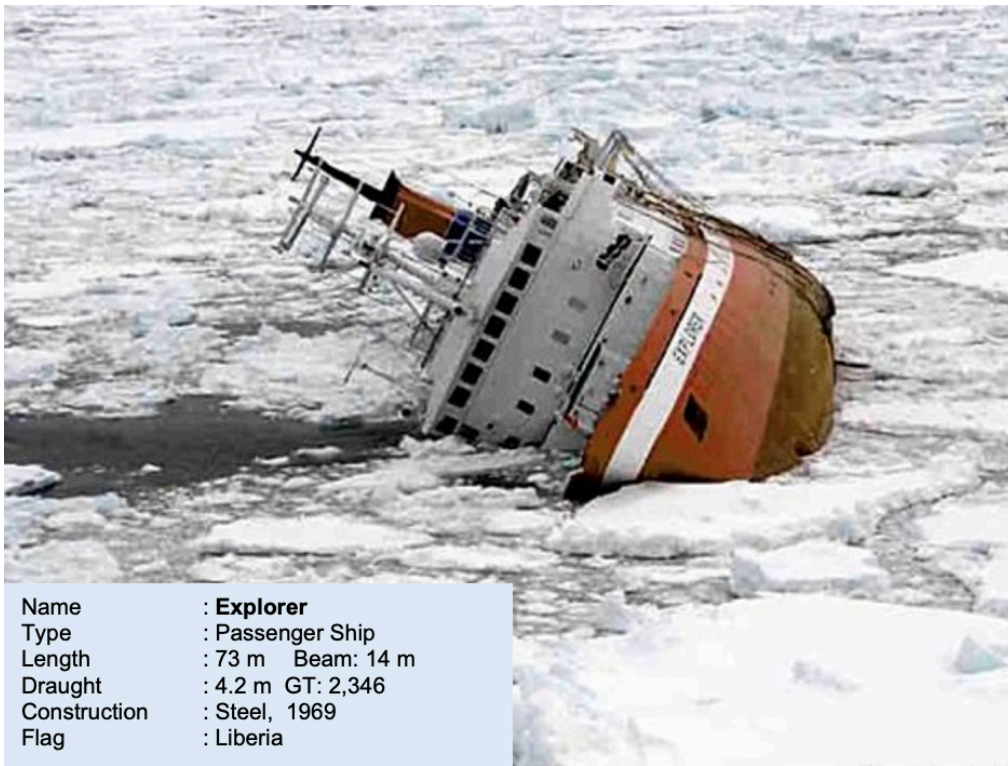
Condition : Floating Ice  
Wind : Calm  
Waves : Calm Sea  
Condition : Night

Name : **Explorer**  
Type : Passenger Ship  
Length : 73 m Beam: 14 m  
Draught : 4.2 m GT: 2,346  
Construction : Steel, 1969  
Flag : Liberia

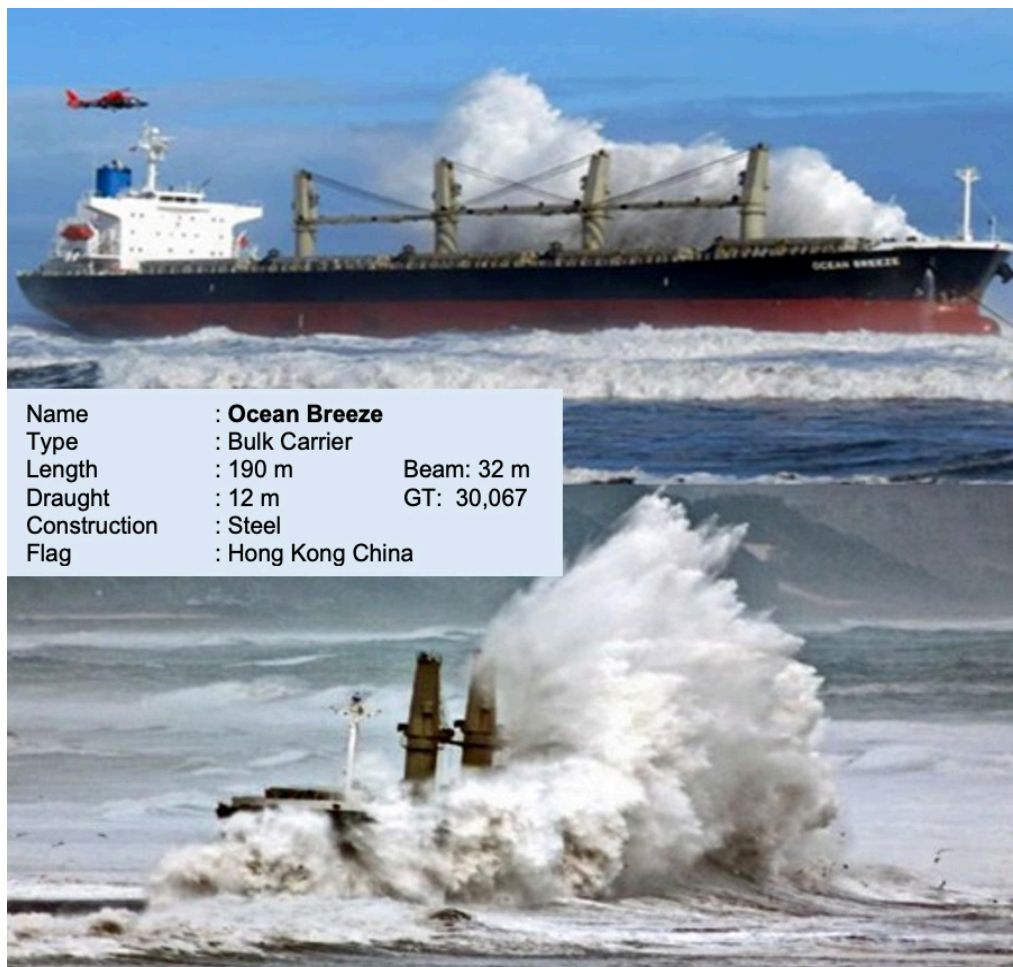
Condition : Storm and abnormal swell  
Wind : 30 knots  
Waves : 4 to 5 m  
Condition : Night

Name : **Ocean Breeze**  
Type : Bulk Carrier  
Length : 190 m      Beam: 32 m  
Draught : 12 m      GT: 30,067  
Construction : Steel  
Flag : Hong Kong China

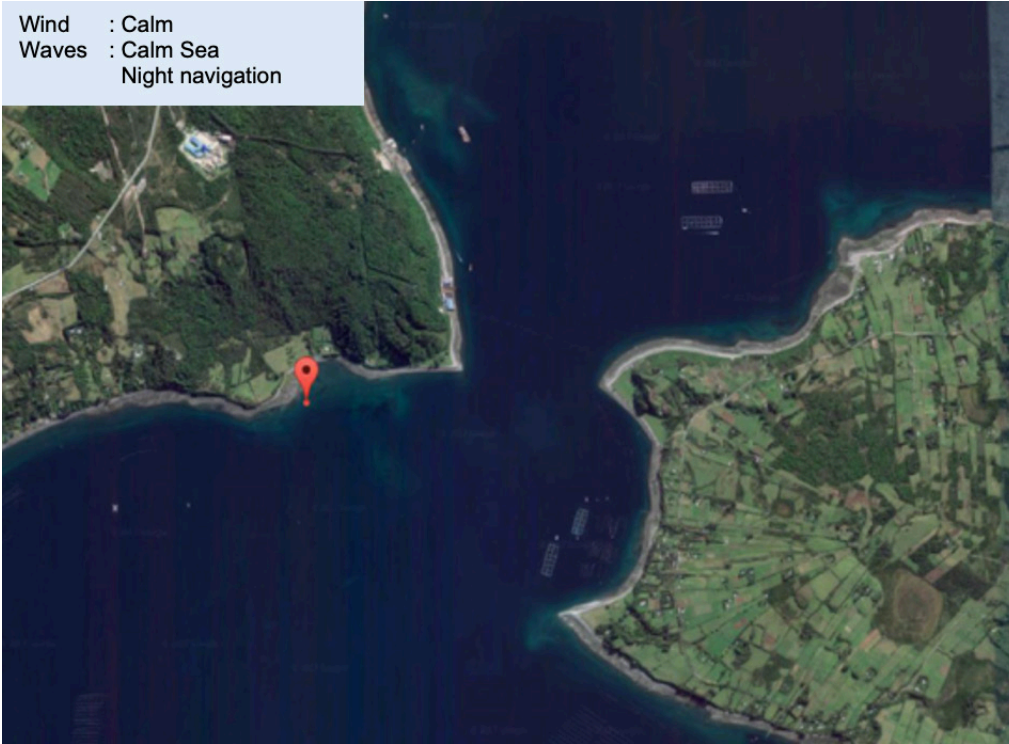
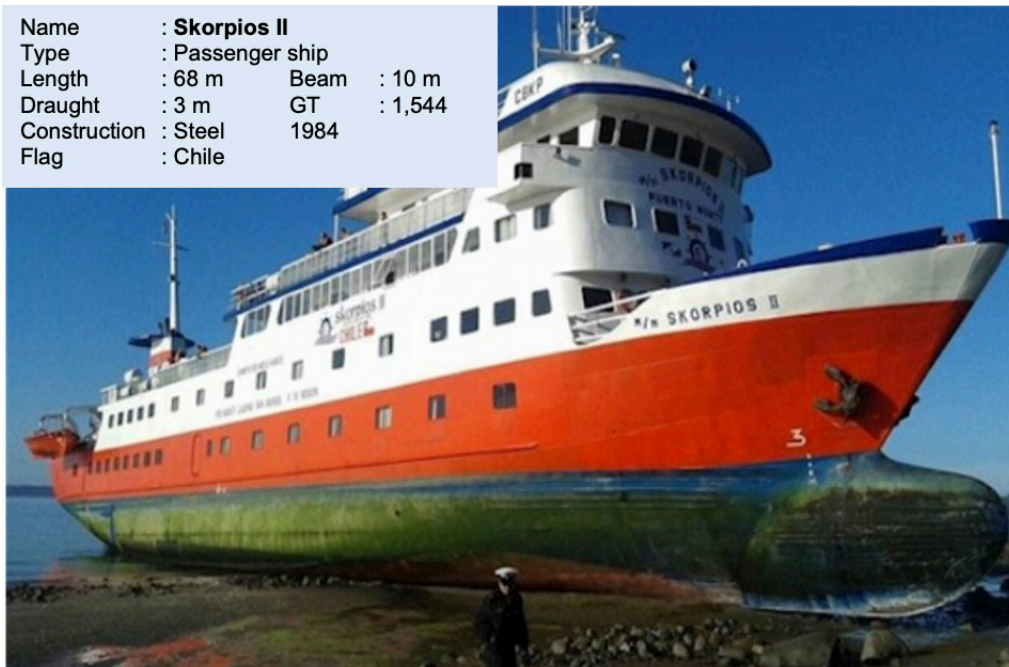
Wind : Calm  
Waves : Calm Sea  
Night navigation

Name : **Skorpios II**  
Type : Passenger ship  
Length : 68 m    Beam : 10 m  
Draught : 3 m    GT : 1,544  
Construction : Steel    1984  
Flag : Chile

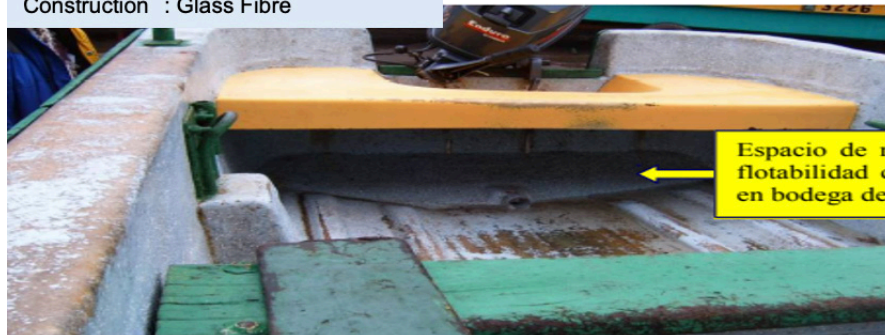
Name	: <b>Daphne Carolina</b>
Type	: Outboard MB
Length	: 7.9 m
Beam	: 2.0 m GT: 5
Construction	: Glass Fibre

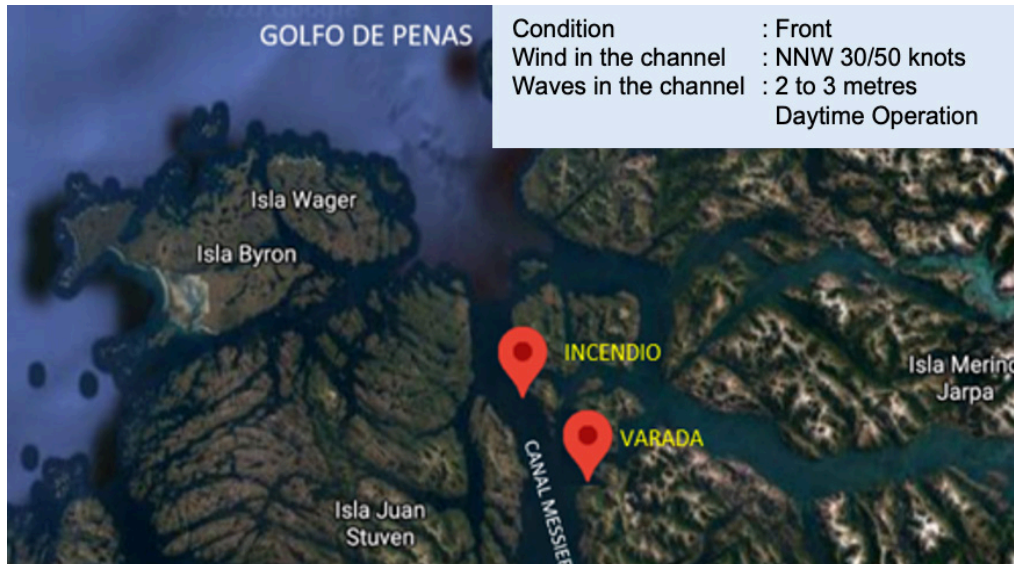
Name : **Condor**  
IMO : 9191632  
Type : Container Ship  
Length : 132 m      Beam : 19 m  
Draught : 7 m.      GT : 6,406  
Construction : Steel      1998  
Flag : Chile

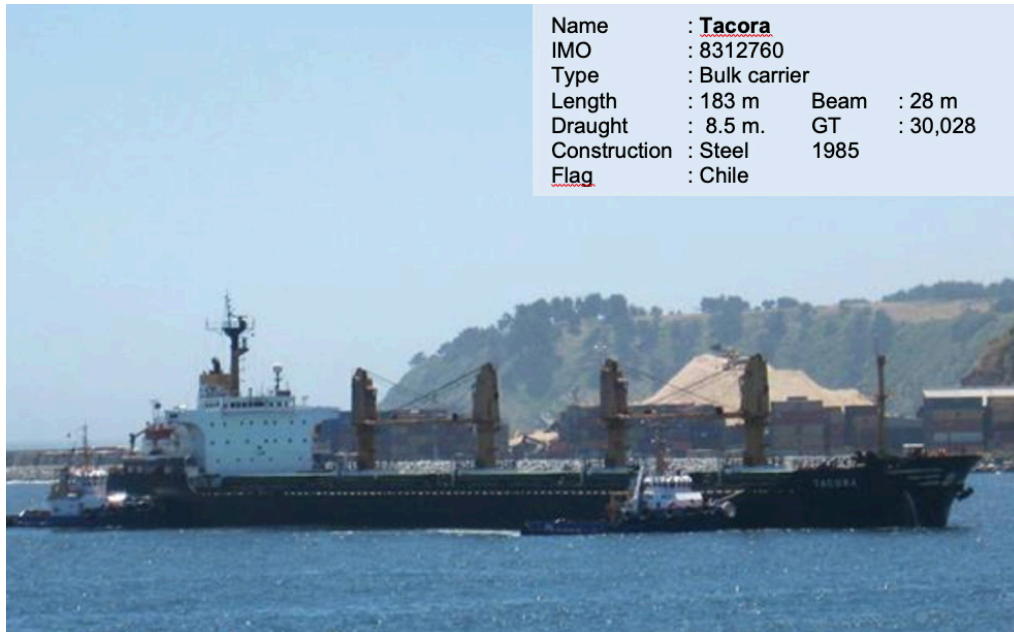
Name : **Tacora**  
 IMO : 8312760  
 Type : Bulk carrier  
 Length : 183 m    Beam : 28 m  
 Draught : 8.5 m    GT : 30,028  
 Construction : Steel    1985  
 Flag : Chile

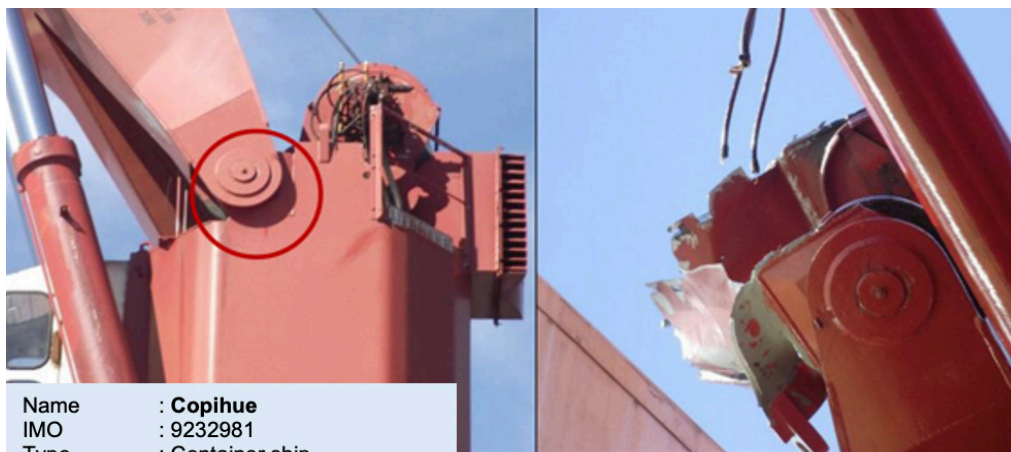
Name : **Copihue**  
 IMO : 9232981  
 Type : Container ship  
 Length : 126 m Beam : 19 m  
 Draught : 8 m GT : 6,385  
 Construction : Steel 2000  
 Flag : Chile

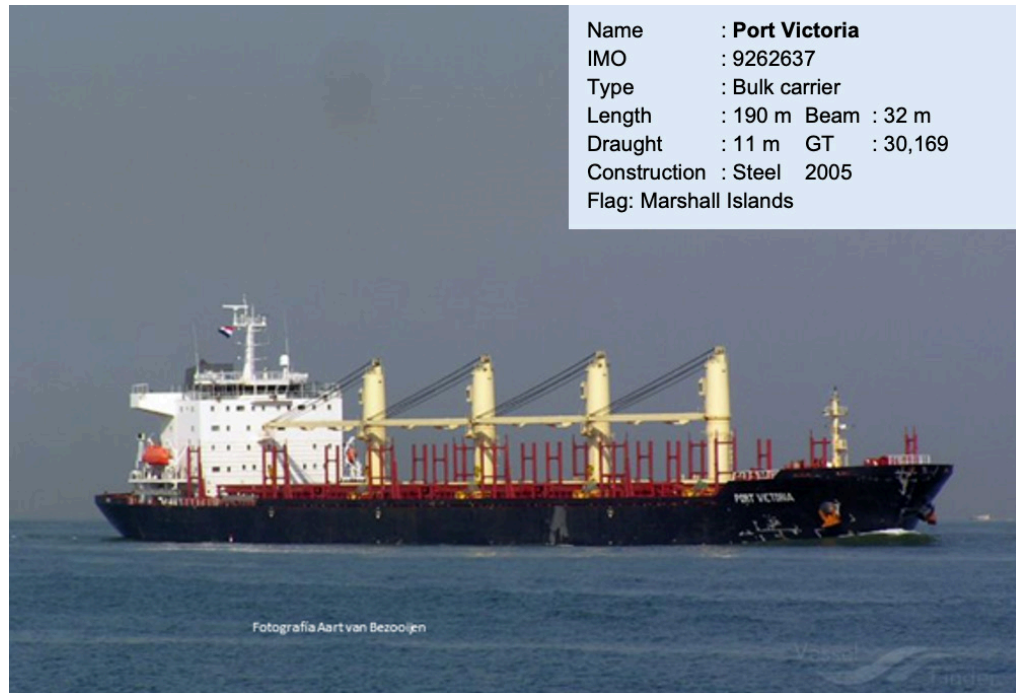
## **FIRE IN CARGO HOLD OF A BULK CARRIER, IN SAN ANTONIO**

In the area of the seat, there were only burned grains and no smoke or flames. There was also a significant accumulation of waste from aluminum hydroxide tablets used during the embarkation as a grain disinfectant, and moisture areas where fungus grew.

During the unloading, they saw intermittent plumes of smoke twice and low flames at specific spots. The burning grains registered temperatures of 70° C and were unloaded directly to the pier floor. The healthy grains were unloaded as usual without any inconvenience.

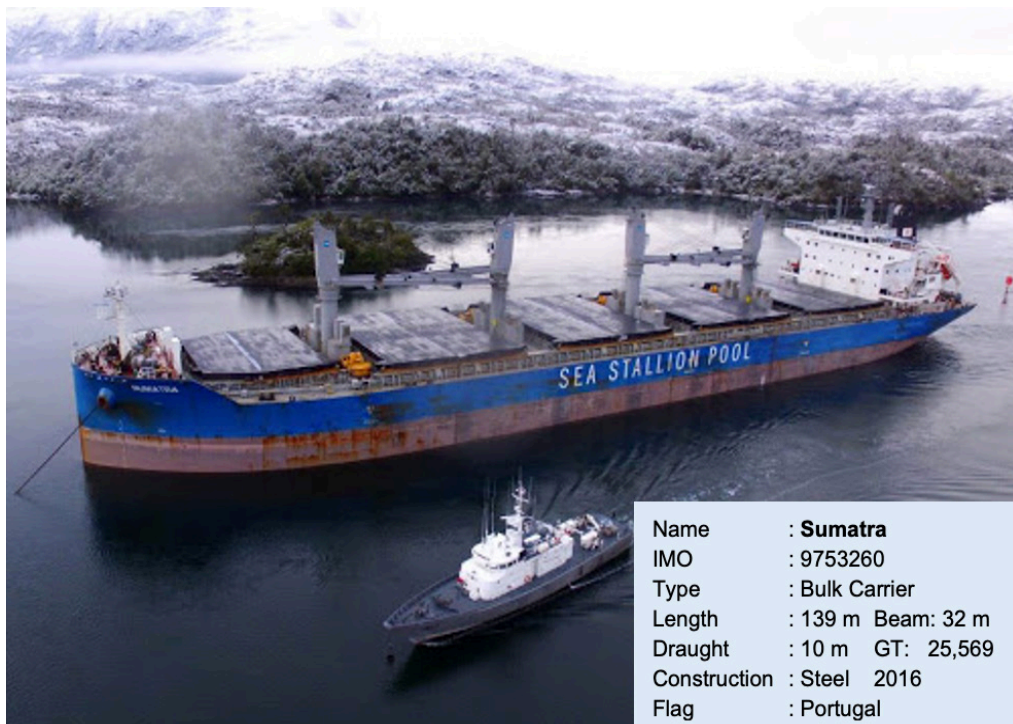
## **GROUNDING OF A BULK CARRIER, IN THE ENGLISH NARROWS**

On 28 June 2018, the Bulk Carrier **Sumatra** grounded in the coast of Wellington island when it navigated in ballast condition North to South through Paso Curvo of the English Narrows, with two pilots on board. The ship entered the narrows at a time close to the stand, with North winds of 10 knots, which made it drift to the South. **The ship started crossing off-track and did not follow the sailing directions**, which noted the importance of not drifting to the South of the range of Disraeli island, as in that case the North edge of Medio Canal island would not allow to see the narrow channel of Paso Curvo and would force the ship to make a **sharp and uncertain turn to the new course**, which happened to the **Sumatra**.

Although the ship **grounded with engines full ahead**, there were no people injured or oil spills. The ship remained afloat, but unfit for navigation due to serious damage to the propulsion and steering systems.

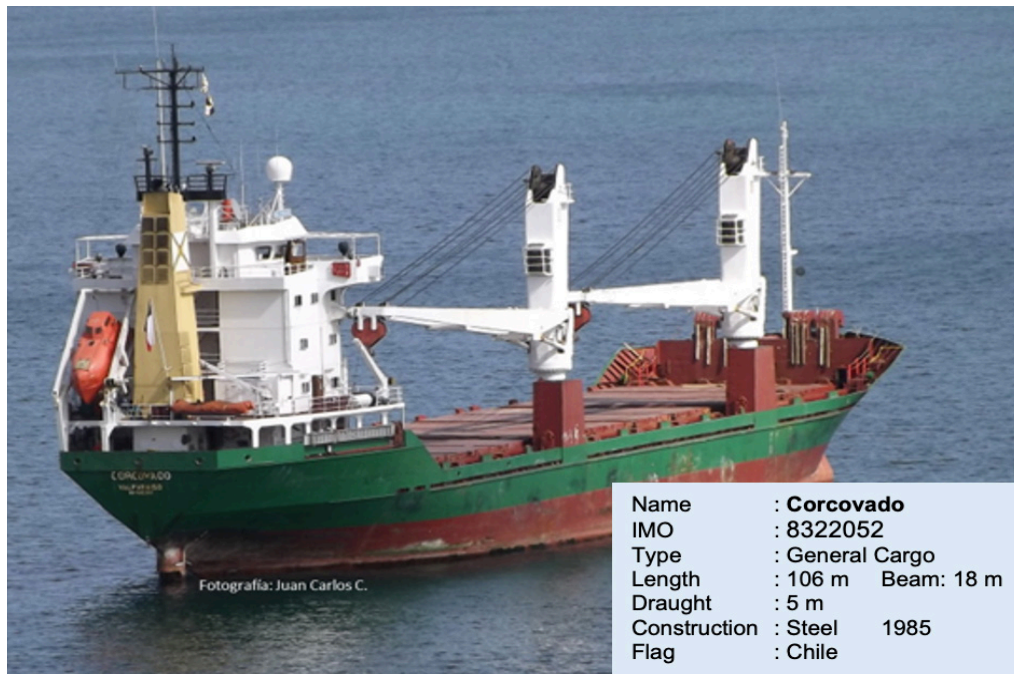
## CONTACT OF A GENERAL CARGO SHIP WITH ICE, IN WIDE CHANNEL

On 31 May 2004, the general Cargo Ship **Corcovado** collided with a block of ice while navigating the Wide channel, which caused a leak in the fore peak tank. The ship was **navigating in the night, in the middle of the channel, and in heavy rain.**

Name : **Corcovado**  
IMO : 8322052  
Type : General Cargo  
Length : 106 m      Beam: 18 m  
Draught : 5 m  
Construction : Steel      1985  
Flag : Chile

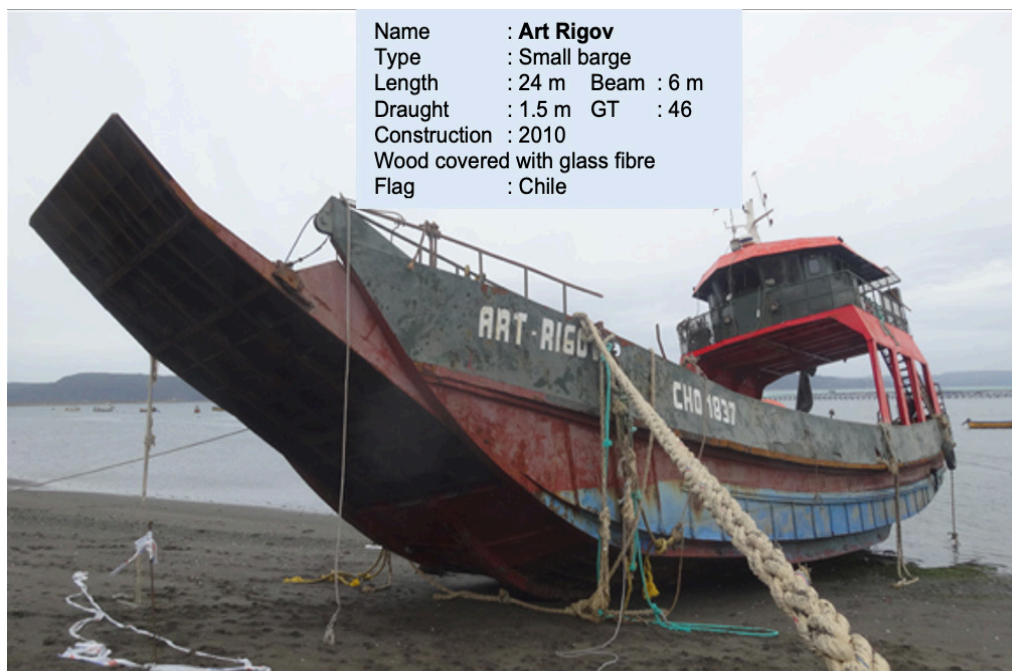
## SINKING OF A SMALL VESSEL, MOORED IN QUEILEN

cut loose and saw the vessel capsize over her starboard side. The hull inspection showed a lack of watertight bulkhead below deck, a lack of caulking, and old damages to the wooden hull. The plastic covering had cracks that allowed leaking, probably during the loading due to deformations and specific stresses to the hull against the pebbly beach. The water leaked slowly accumulated in the stern side, in the engine area, and was not noticed timely, causing the sinking. The bilge alarm was functioning, but it was disabled from the switch in the bridge.

Name : **Art Rigov**  
Type : Small barge  
Length : 24 m Beam : 6 m  
Draught : 1.5 m GT : 46  
Construction : 2010  
Wood covered with glass fibre  
Flag : Chile
